**ASSOCIATION OF MANITOBA MUNICIPALITIES  
MANITOBA MUNICIPAL ENERGY, WATER AND WASTE  
WATER EFFICIENCY PROJECT  
TOWN OF BIRTLE  
FINAL REPORT  
JANUARY 2006**

RE: Municipal Energy, Water, and Wastewater  
Efficiency Studies for Birtle – Final Report

The objective of this study was to determine energy, water, and waste water efficiency opportunities that could enable the town of Birtle to reduce operating costs, conserve resources, and reduce greenhouse gas emissions.

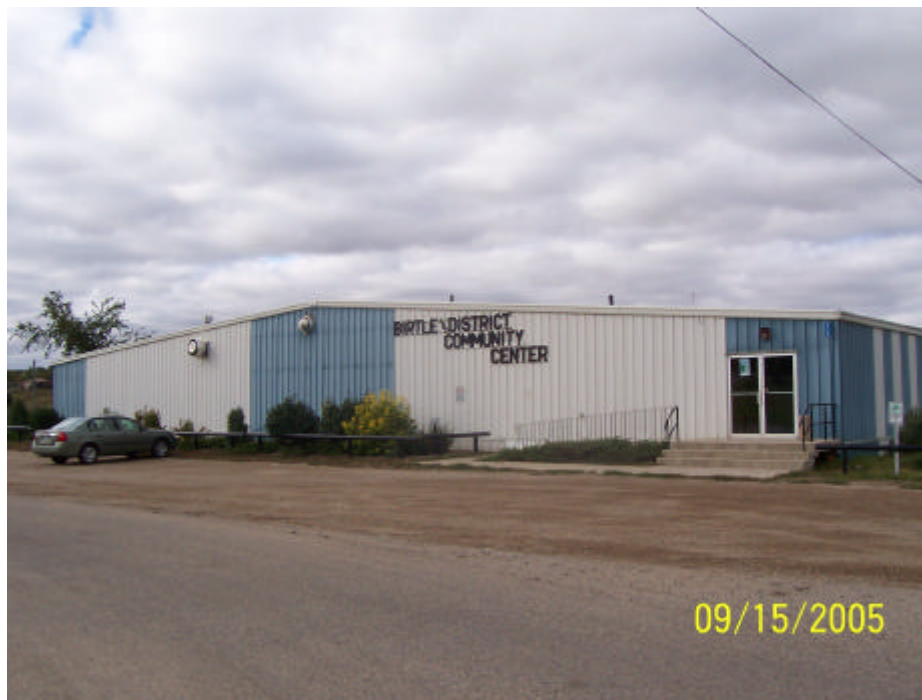
**Photo 1 - Community Centre**

The Birtle Community Centre is a 30,625 square foot metal frame structure with metal cladding on both the inside and outside walls separated by 10" of insulation. The Community Centre was constructed in 1975-1976 and houses a skating rink, a reception area, and change rooms in the basement. This building is occupied regularly in the winter months (October to March) while in the summer it is occupied approximately once a month for special events.

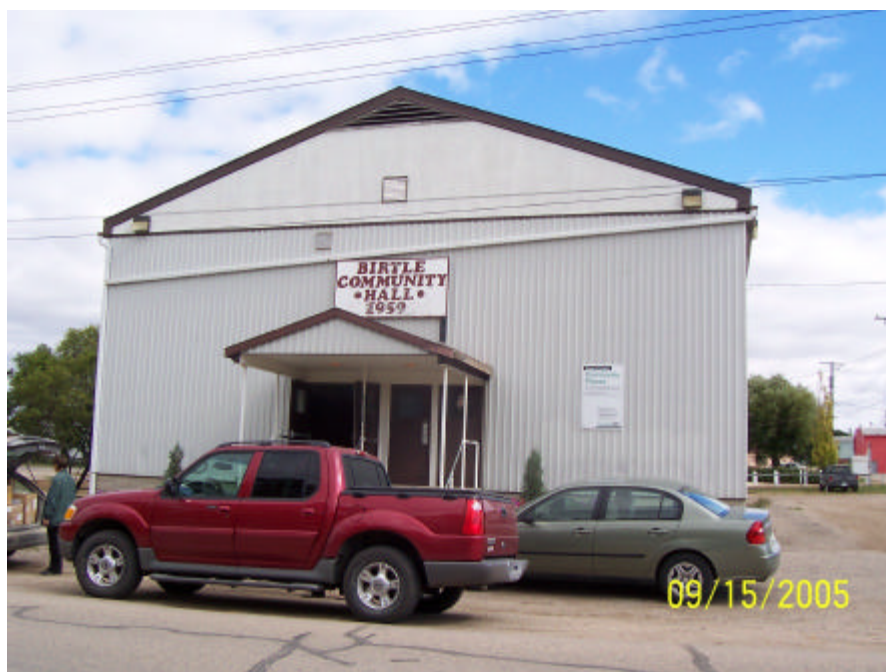
**Photo 2 Community Hall**

Birtle Community Hall, built in 1959, is a 4,500 square foot building constructed of concrete block and exterior metal cladding. The walls have recently been insulated with 1 ½" Styrofoam and the roof is insulated with 12" thick blow-in insulation. The hall is used for Bingo once a week (3 hours) and for approximately two socials per month (4 hours each).

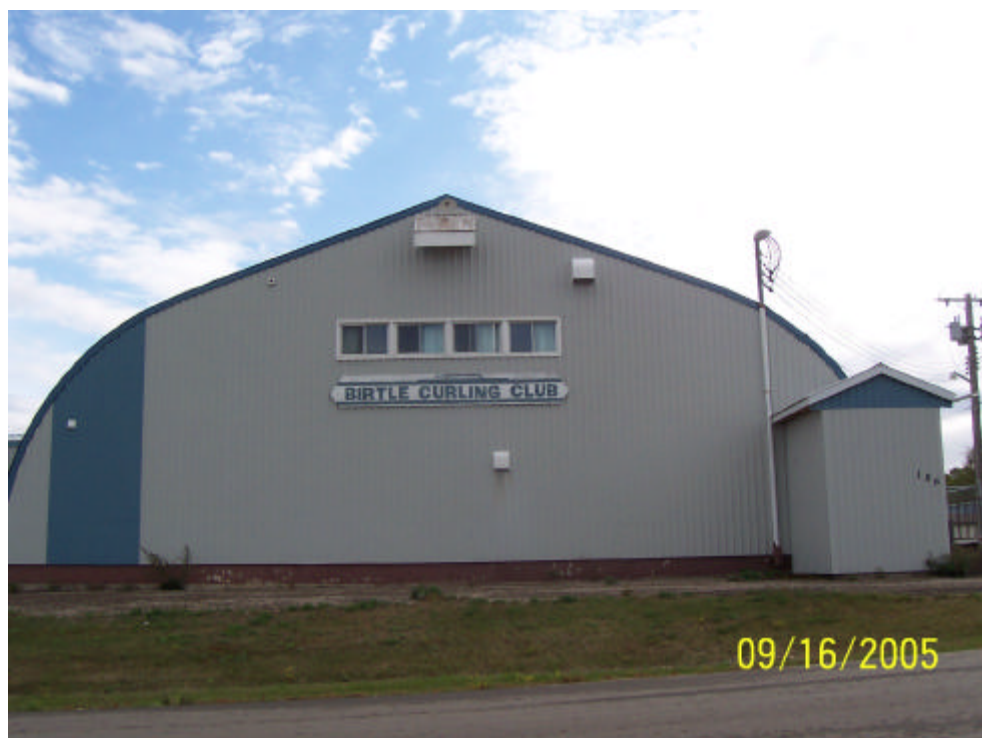
**Photo 3 - Curling Club**

The Curling Club, built in 1970-1971, is a two-story, 10,500 square foot metal clad building with a lounge on both the main floor and upstairs overlooking the curling rink. The Curling Club is open for six months of the year with a maximum occupancy of approximately 75 people.

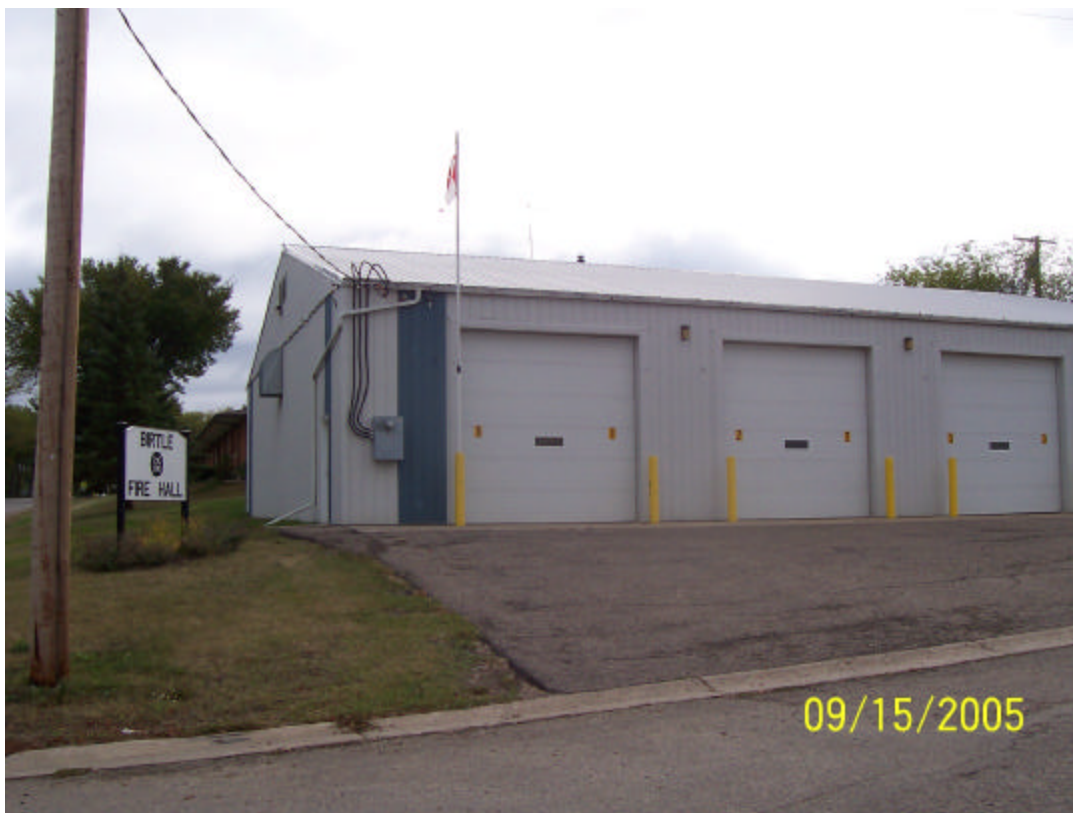
**Photo 4 - Fire Hall**

The Fire Hall is a 4,800 square foot metal frame structure with a metal liner on both the inside and outside walls separated by 6" of insulation. The building was constructed in 1995 and contains a truck bay, an office, and a washroom. The fire hall is only occupied intermittently for service and in the case of a fire/emergency situation.

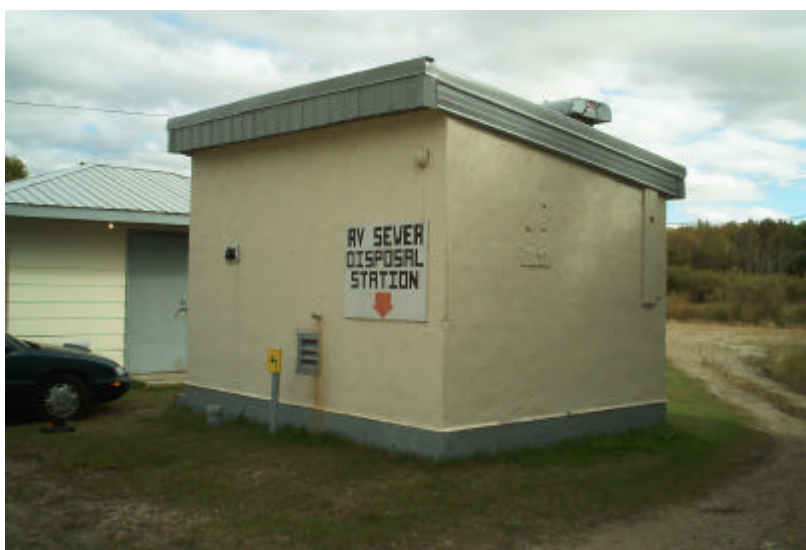
**Photo 5- Sewage Lift Station**

The Sewage Lift Station was built in 1960 and consists of two small buildings of approximately 270 square feet each. One of the buildings houses the generator for the pumps in case of a power failure, while the other is the sewage pumping station. The lift station is occupied periodically for servicing.

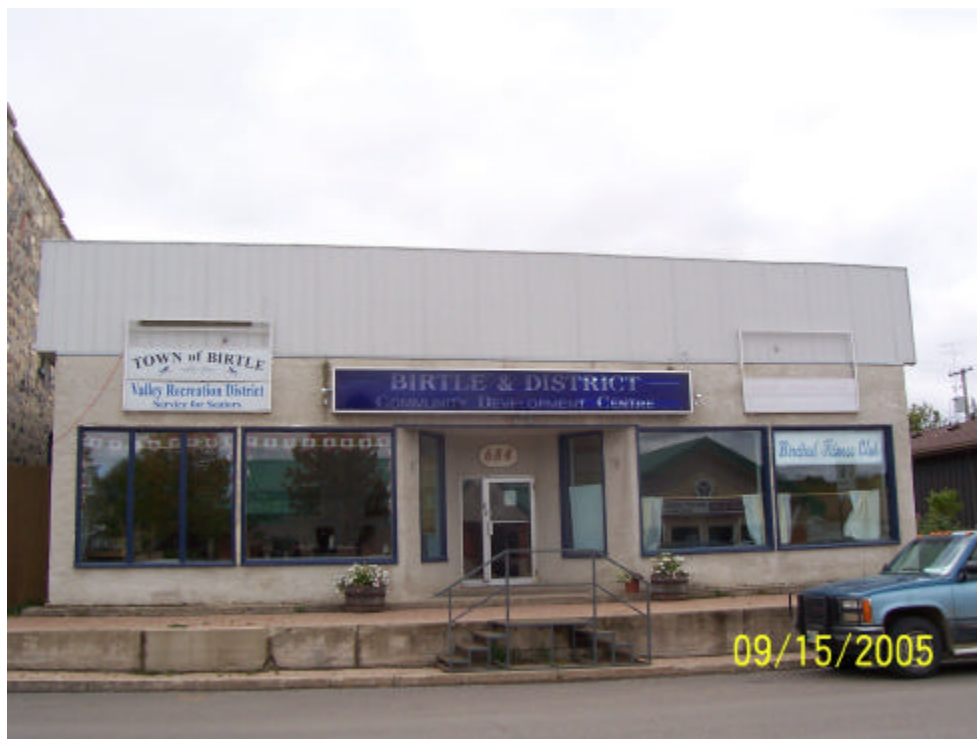
**Photo 7 - Resource Centre**

The Resource Centre is a 4,700 square foot building that houses municipal offices and a fitness club. In 1997, the inside of this building was reconstructed. A program was set up with Manitoba Hydro to upgrade these walls by adding 7" thick insulation for a total wall thickness of 10-12". The offices in this building are occupied year round for 40 hours a week.

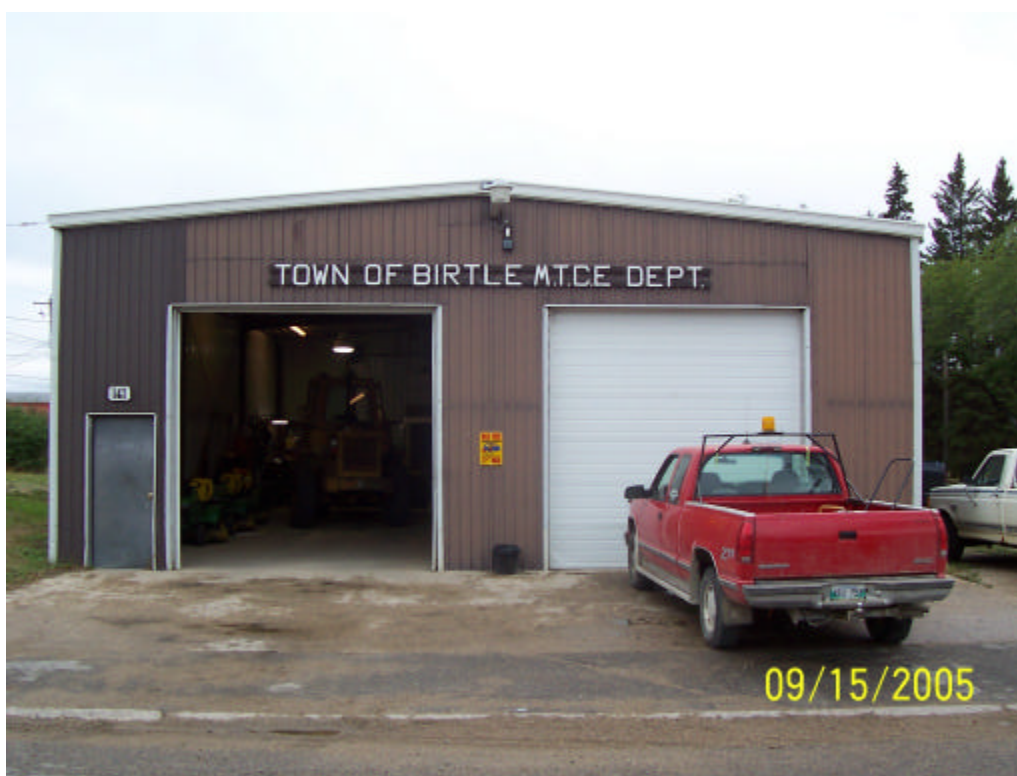
**Photo 8 – Municipal Garage**

Maintenance for town vehicles and equipment is performed at the Municipal Garage. This 1,836 square foot building was constructed in 1982 of metal framing with metal cladding on both the inside and outside walls. The garage is occupied Monday to Friday from 8am to 5pm year round.

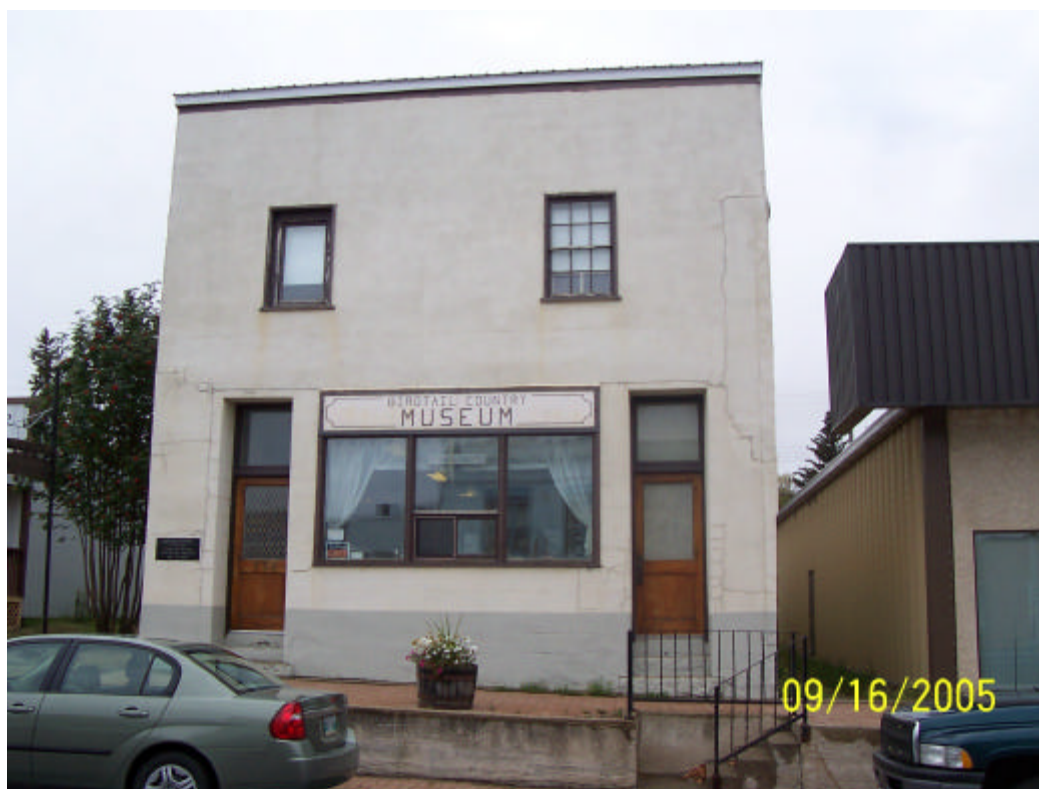
**Photo 9 - Birdtail Country Museum**

The Birdtail Country Museum is a heritage building constructed in 1902. This two-story building is 3,500 square feet and is constructed of masonry covered with stucco on the east and west walls and metal/wood cladding on the south wall. There is no insulation in these walls but the roof was recently repaired and insulated.

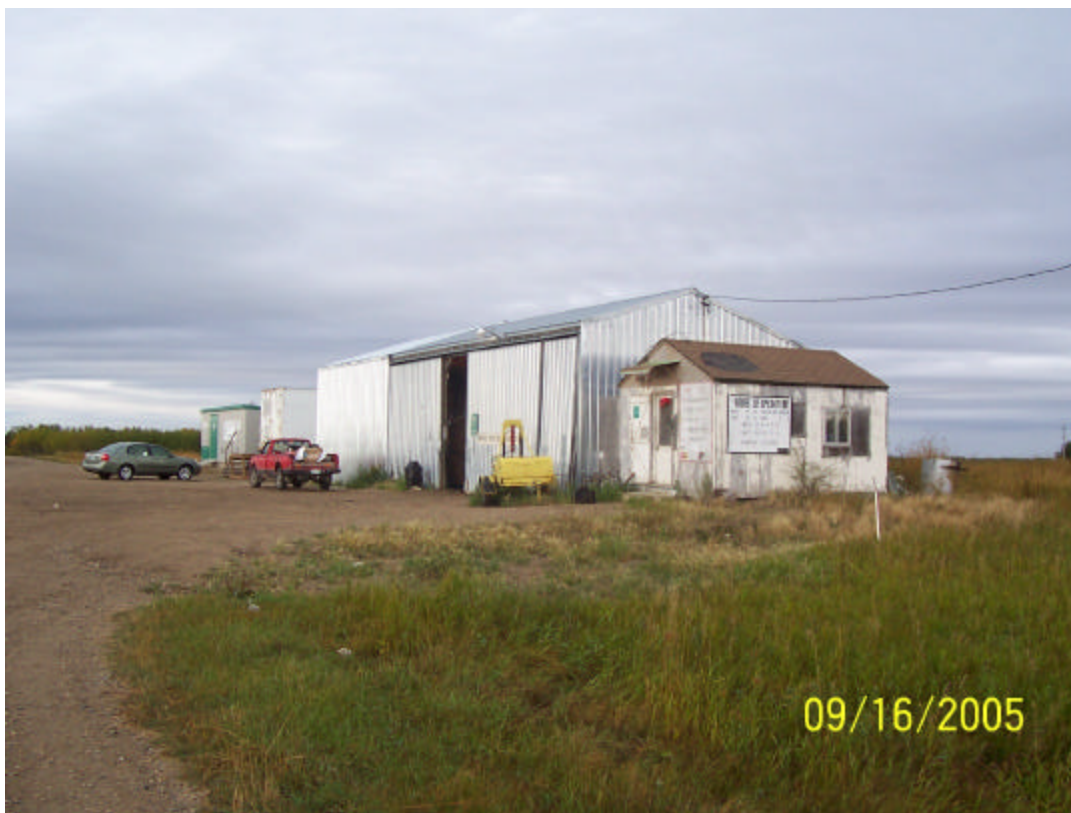
**Photo 10- Recycling Depot**

The Recycling Depot is an old 192 square foot wood building with no insulation. There is one old door and two old leaky windows. This building is occupied for approximately 17 hours per week year round.

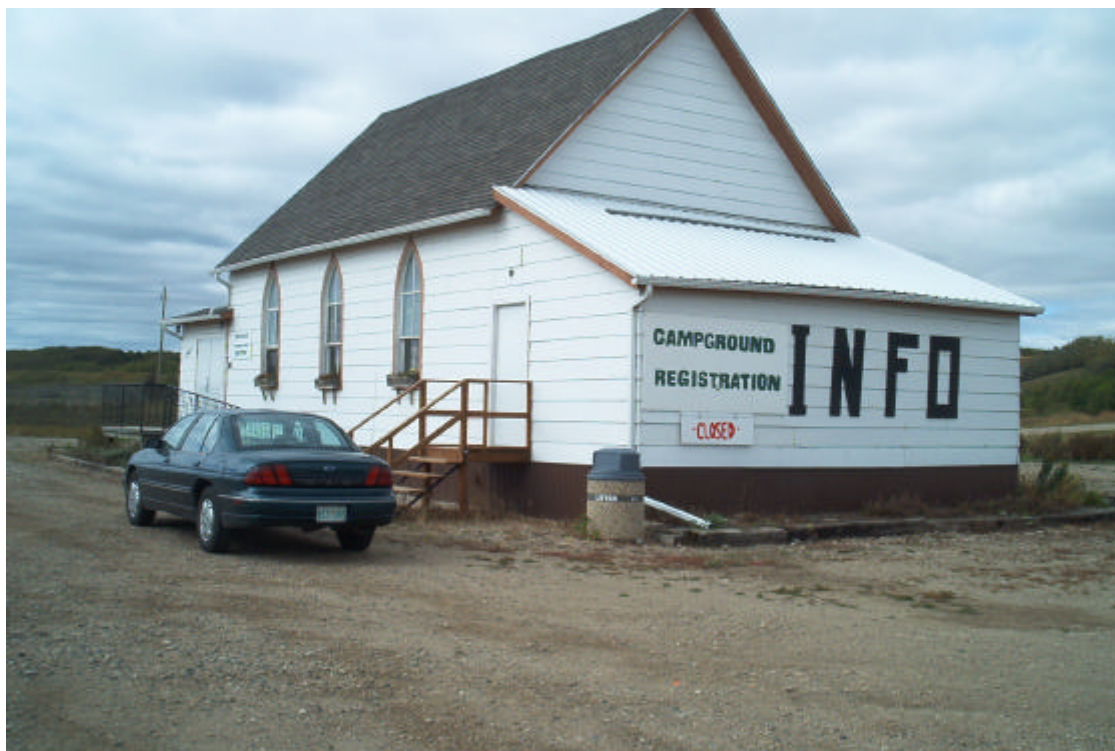
**Photo 11 - Tourist Information Building**

The Tourist Information Building is an old church constructed in the early 1900s. This wood frame structure is 1,475 square feet with no insulation in either the walls or the roof. Insulation is not required in this building as it is only occupied in the summer months. In the winter, the heat is shut off.

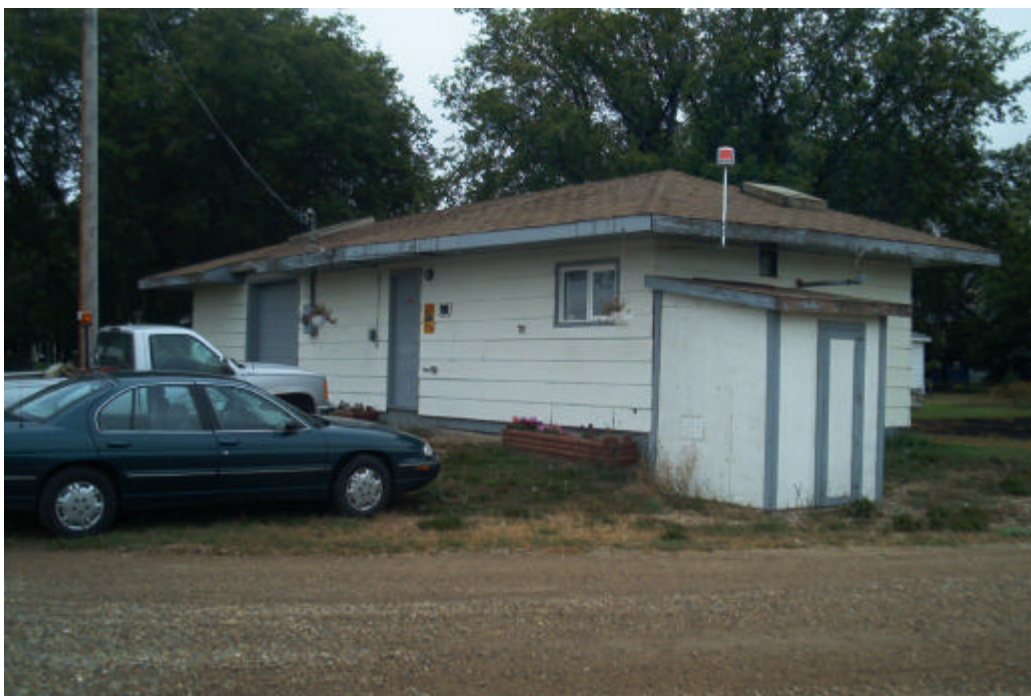
**Photo 12 - Water Treatment Plant**

The Water Treatment Plant consists of an old section that was constructed in approximately 1960 and houses the water filters and a new section that was constructed in 1986 and houses the raw water pumps and chemical feed containers.

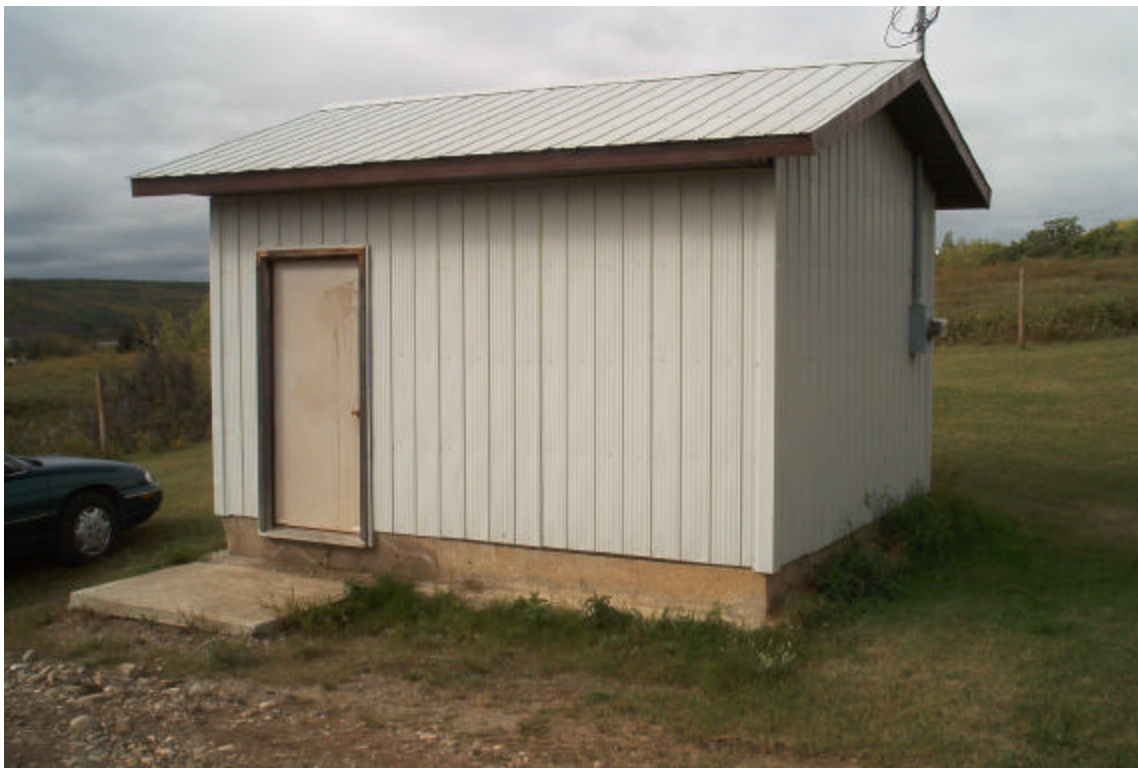
**Photo 14 - North Hill Booster Station**

The North Hill Booster Station is a 215 square foot structure that houses A 7.5 HP pump that operates 24 hours a day year round. This building was constructed in 1988 of wood 2 x 4s, fiberglass insulation, a metal clad exterior, and a plywood clad interior. This station is occupied intermittently for servicing.

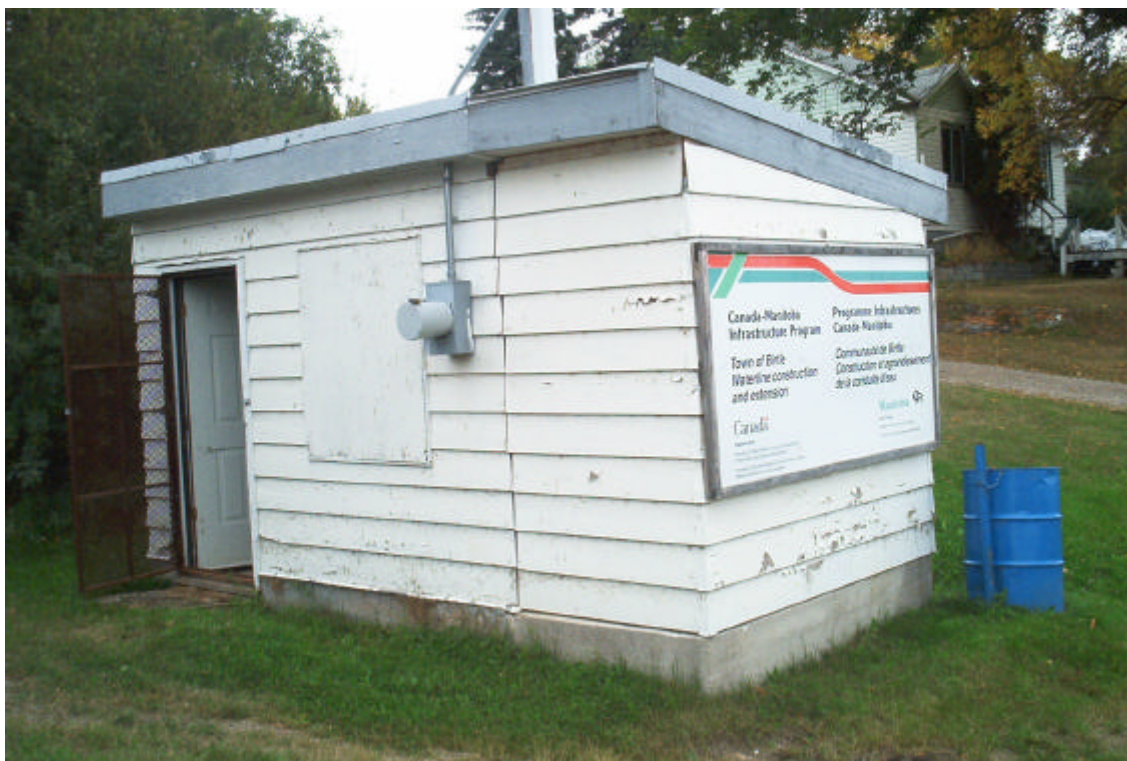
**Photo 15 - South Hill Booster Station**

The South Hill Booster Station is a 215 square foot structure that houses a 7.5 HP pump. This building was constructed in the 1960s of wood 2 x 4s, fiberglass insulation, and wood exterior siding. This station is occupied intermittently for servicing.
